## Distributor - Stair Nosing Australia

### FRP Stair Nosing

## TEST REPORT

Sample Name : FRP ANTI-SLIP STRIP  
 Material : FRP  
 Spec. : 5# EMERY

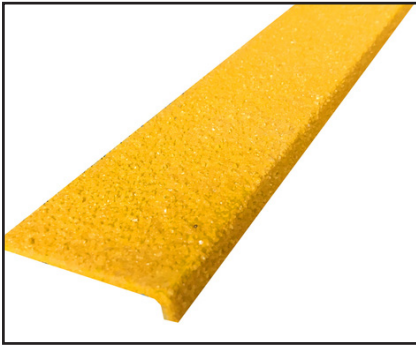
#### **FRP Stair Nosing 70mm x 10mm**

**SKU:** FRP70X10  
**Material:** FRP  
**Colour:** Yellow  
**Slip Rating:** P5  
**Width:** 70mm  
**Nose/Face:** 10mm

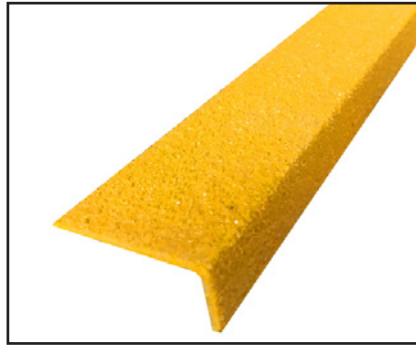
#### **FRP Stair Nosing 70mm x 30mm**

**SKU:** FRP70X30  
**Material:** FRP  
**Colour:** Yellow  
**Slip Rating:** P5  
**Width:** 70mm  
**Nose/Face:** 30mm

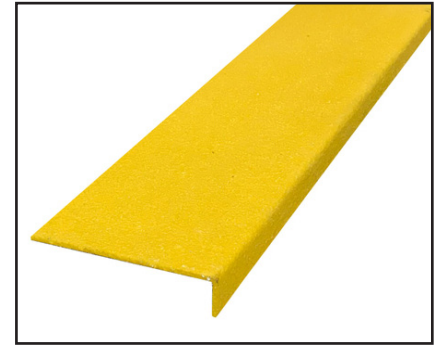
#### **FRP Stair Nosing 150mm x 30mm**

**SKU:** FRP150X30  
**Material:** FRP  
**Colour:** Yellow  
**Slip Rating:** P5  
**Width:** 150mm  
**Nose/Face:** 30mm

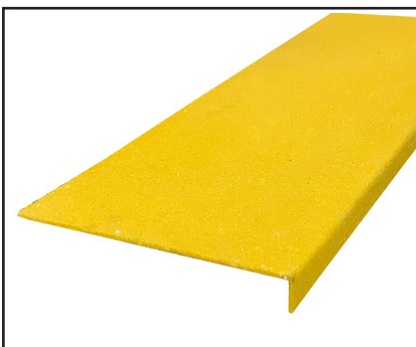
#### **FRP Stair Nosing 230mm x 30mm**

**SKU:** FRP230X30  
**Material:** FRP  
**Colour:** Yellow  
**Slip Rating:** P5  
**Width:** 230mm  
**Nose/Face:** 30mm
